GREAT NEAPOLITAN EARTHQUAKE OF 1857.

OBSERVATIONAL SEISMOLOGY

TO INVESTIGATE THE CIRCUMSTANCES OF THE GREAT
EARTHQUAKE OF DECEMBER 1857.

ROBERT MALLET, C.E., F.R.S., F.G.S., M.R.I.A.,
&c., &c.

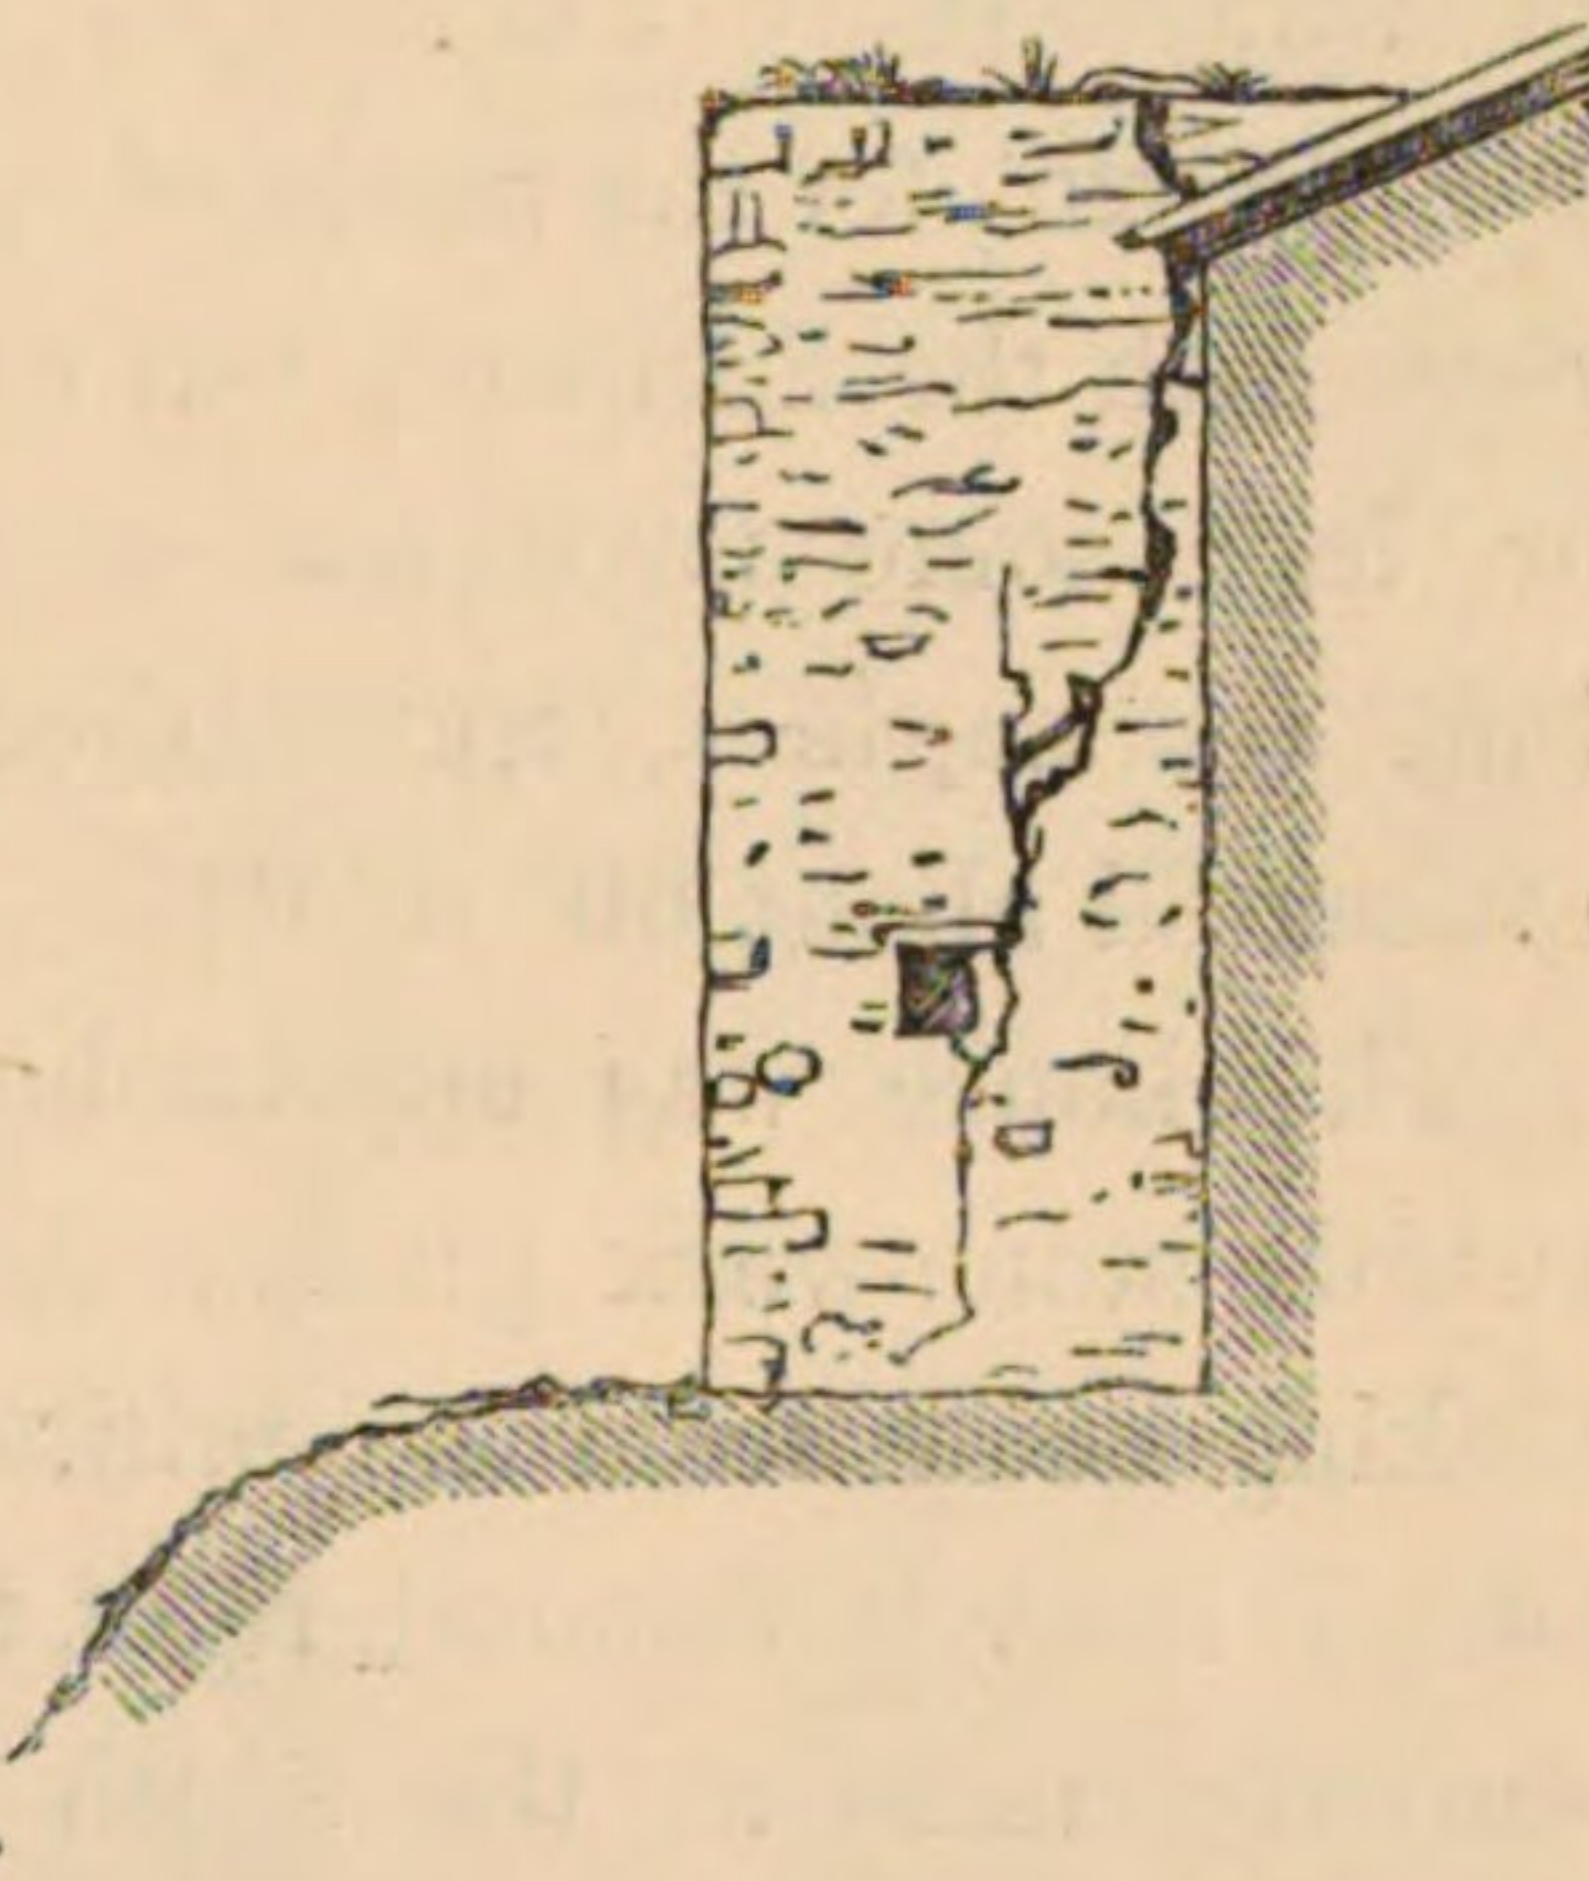
Fig. 141.

The fissures at the internal flanks of the tower, that, T, (ground plan, Fig. 139), looking south, and that, V, looking north, are pretty exactly sketched in Figs. 140 and 141.

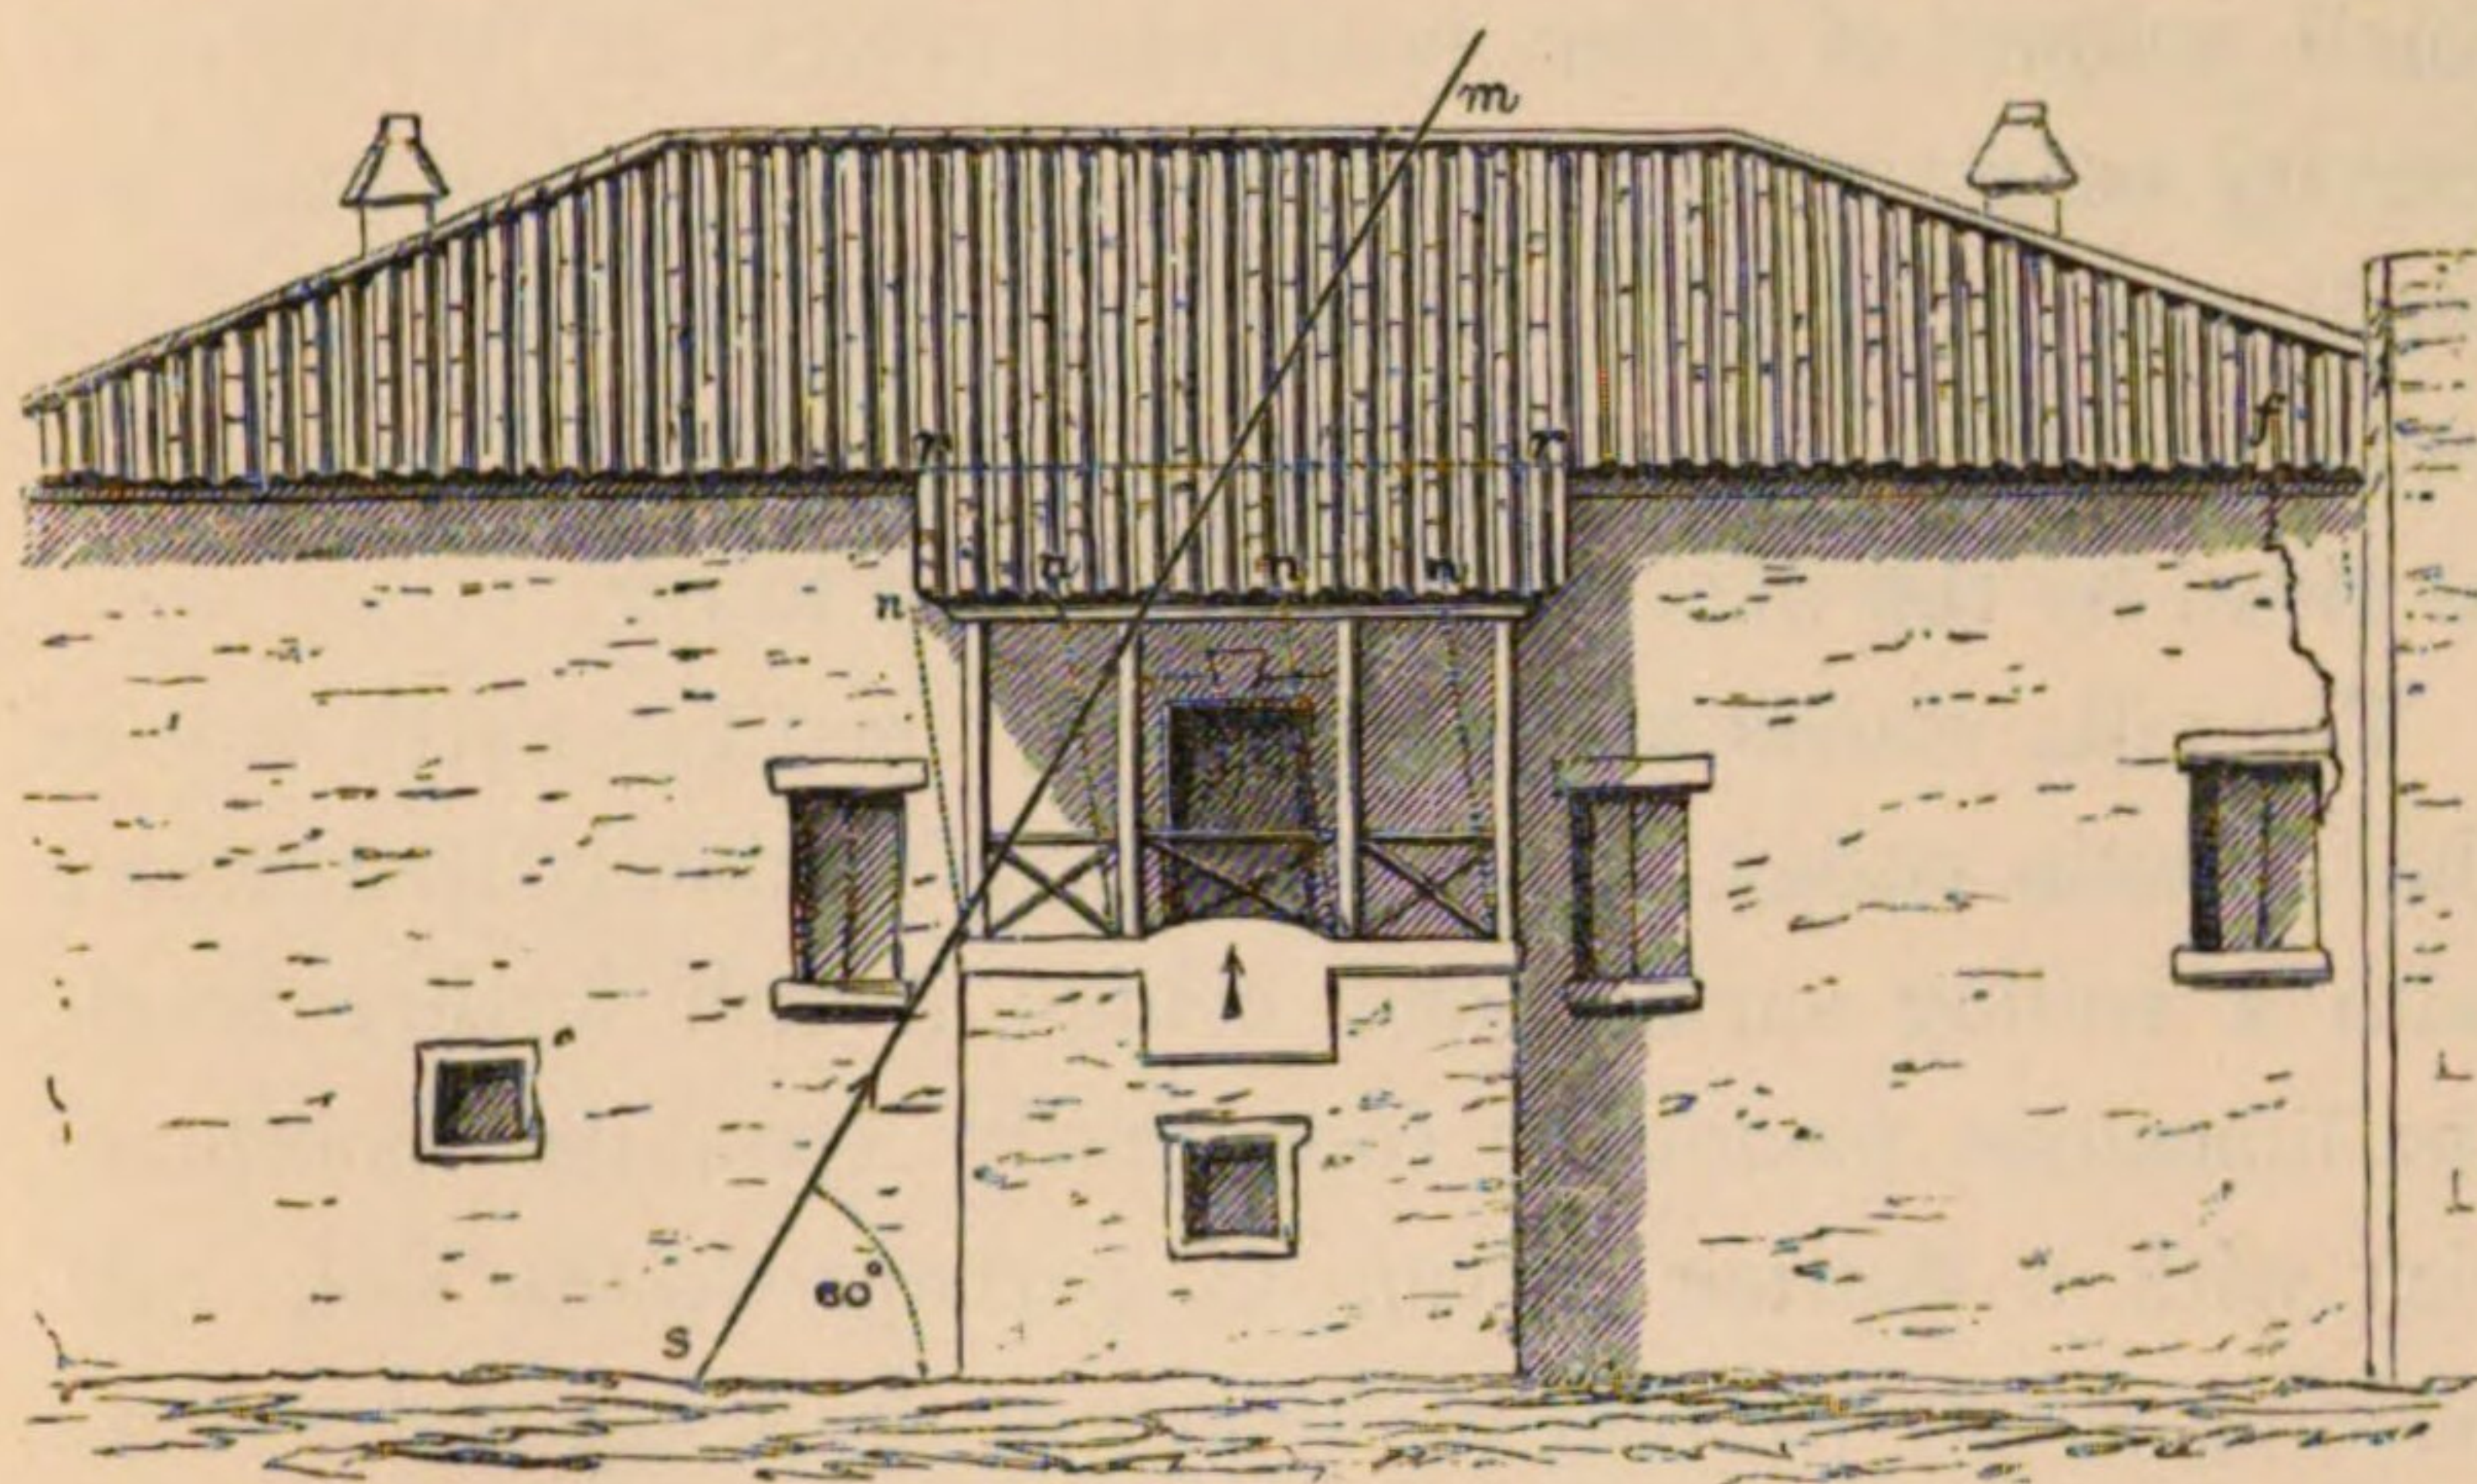
Fig. 142.

(which corresponds to that above the "Portone" of the south front) stood, before the earthquake, a wooden sort of verandah, framed, as shown in Fig. 142, and covered by a

prolongation of the slope of tiling of the roof. The whole of this had been thrown down, and was lying on the ground at and about the point *s* (in Figs. 139, 142, and Photog. No. 138) in dislocated fragments, from which, collecting and laying together the timber-work, I was able to reconstruct the design of the fabric.

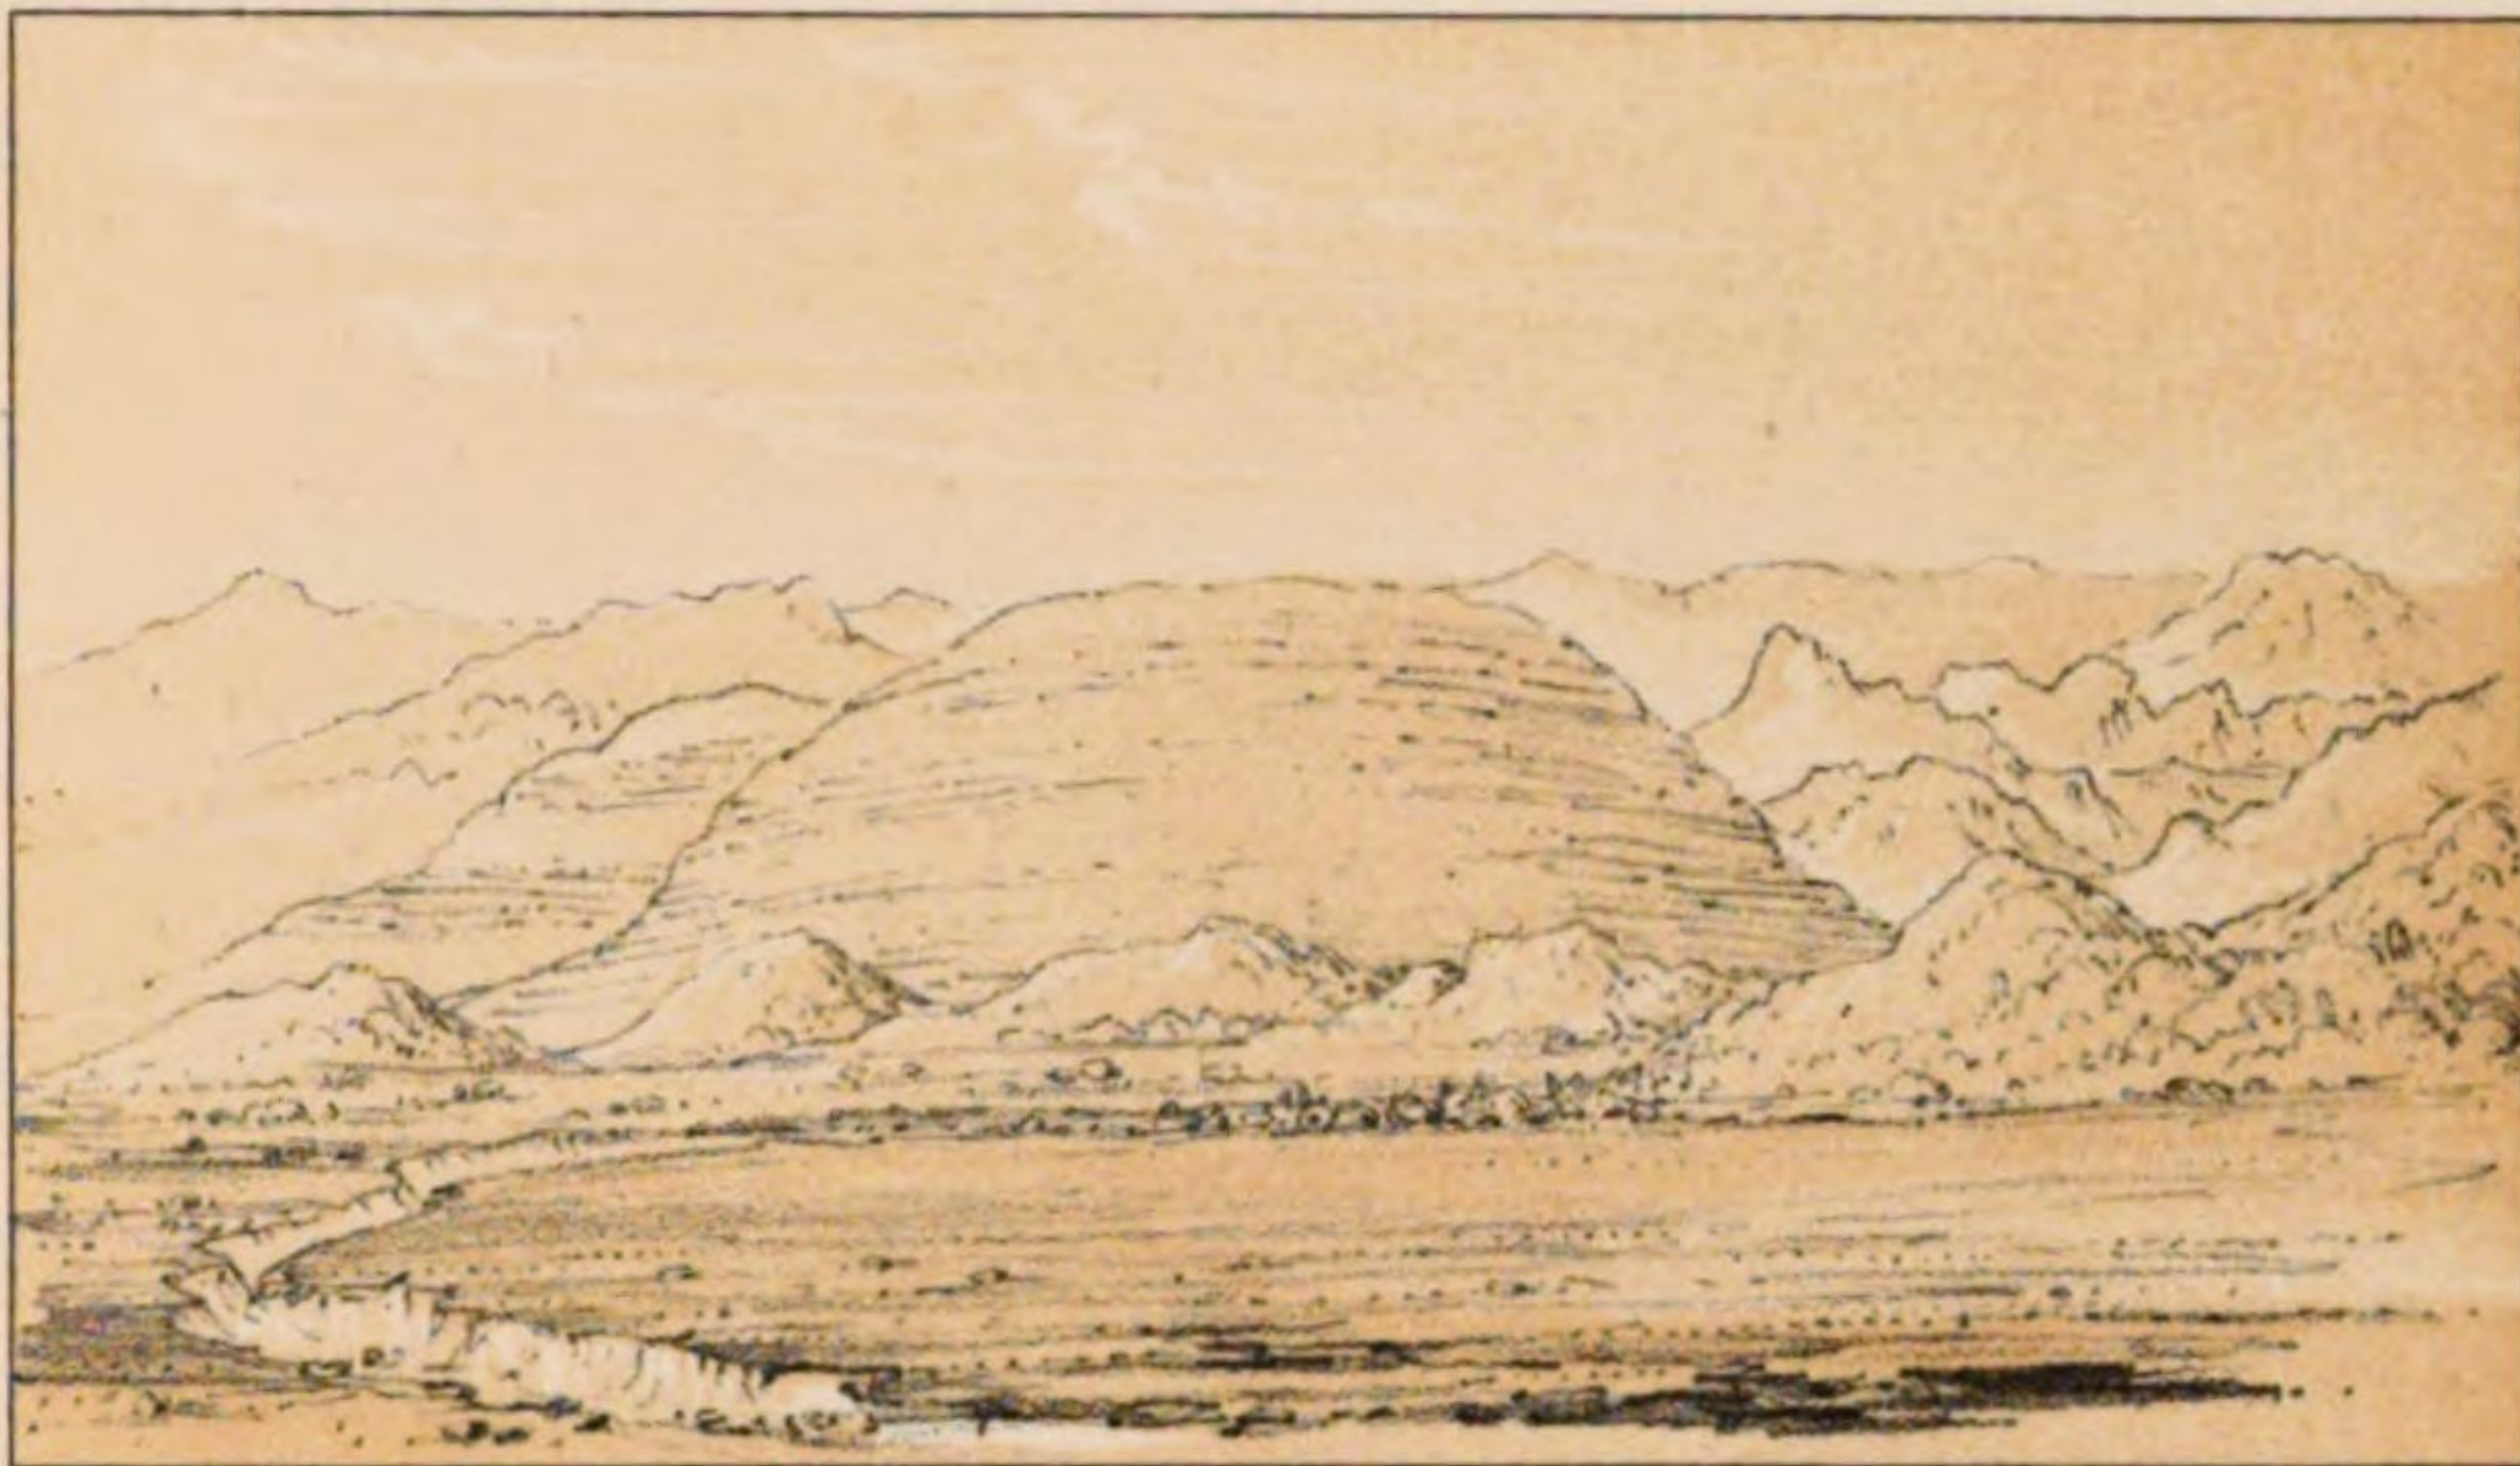
The shock emerging from the eastward had swept over the vertical posts towards the direction of the dotted lines *n n n n*, and the tiling of the roof had rent away from the rest at the line of the eave *r r*, twisting and drawing out the cross lintels from their sockets in the walls of the house at the eaves, the whole mass then falling in the direction of *m s*. The weight of the timber-work was insignificant, the chief mass was in the heavy tiling which it carried. A line drawn from the position of the centre of gravity of this (the projecting tiled roof) to the centre of gravity of

the mass of rubbish upon the ground, I found made an angle of 60° with the level ground. This is, therefore, about the angle of emergence; but as the roof received a small amount of nearly horizontal motion at its centre of gravity before it began to descend, this angle is a little too small, and so it may be taken as about 62° to 64° , coinciding as thus separately determined, with the emergence as given by the tiles projected from the tower.

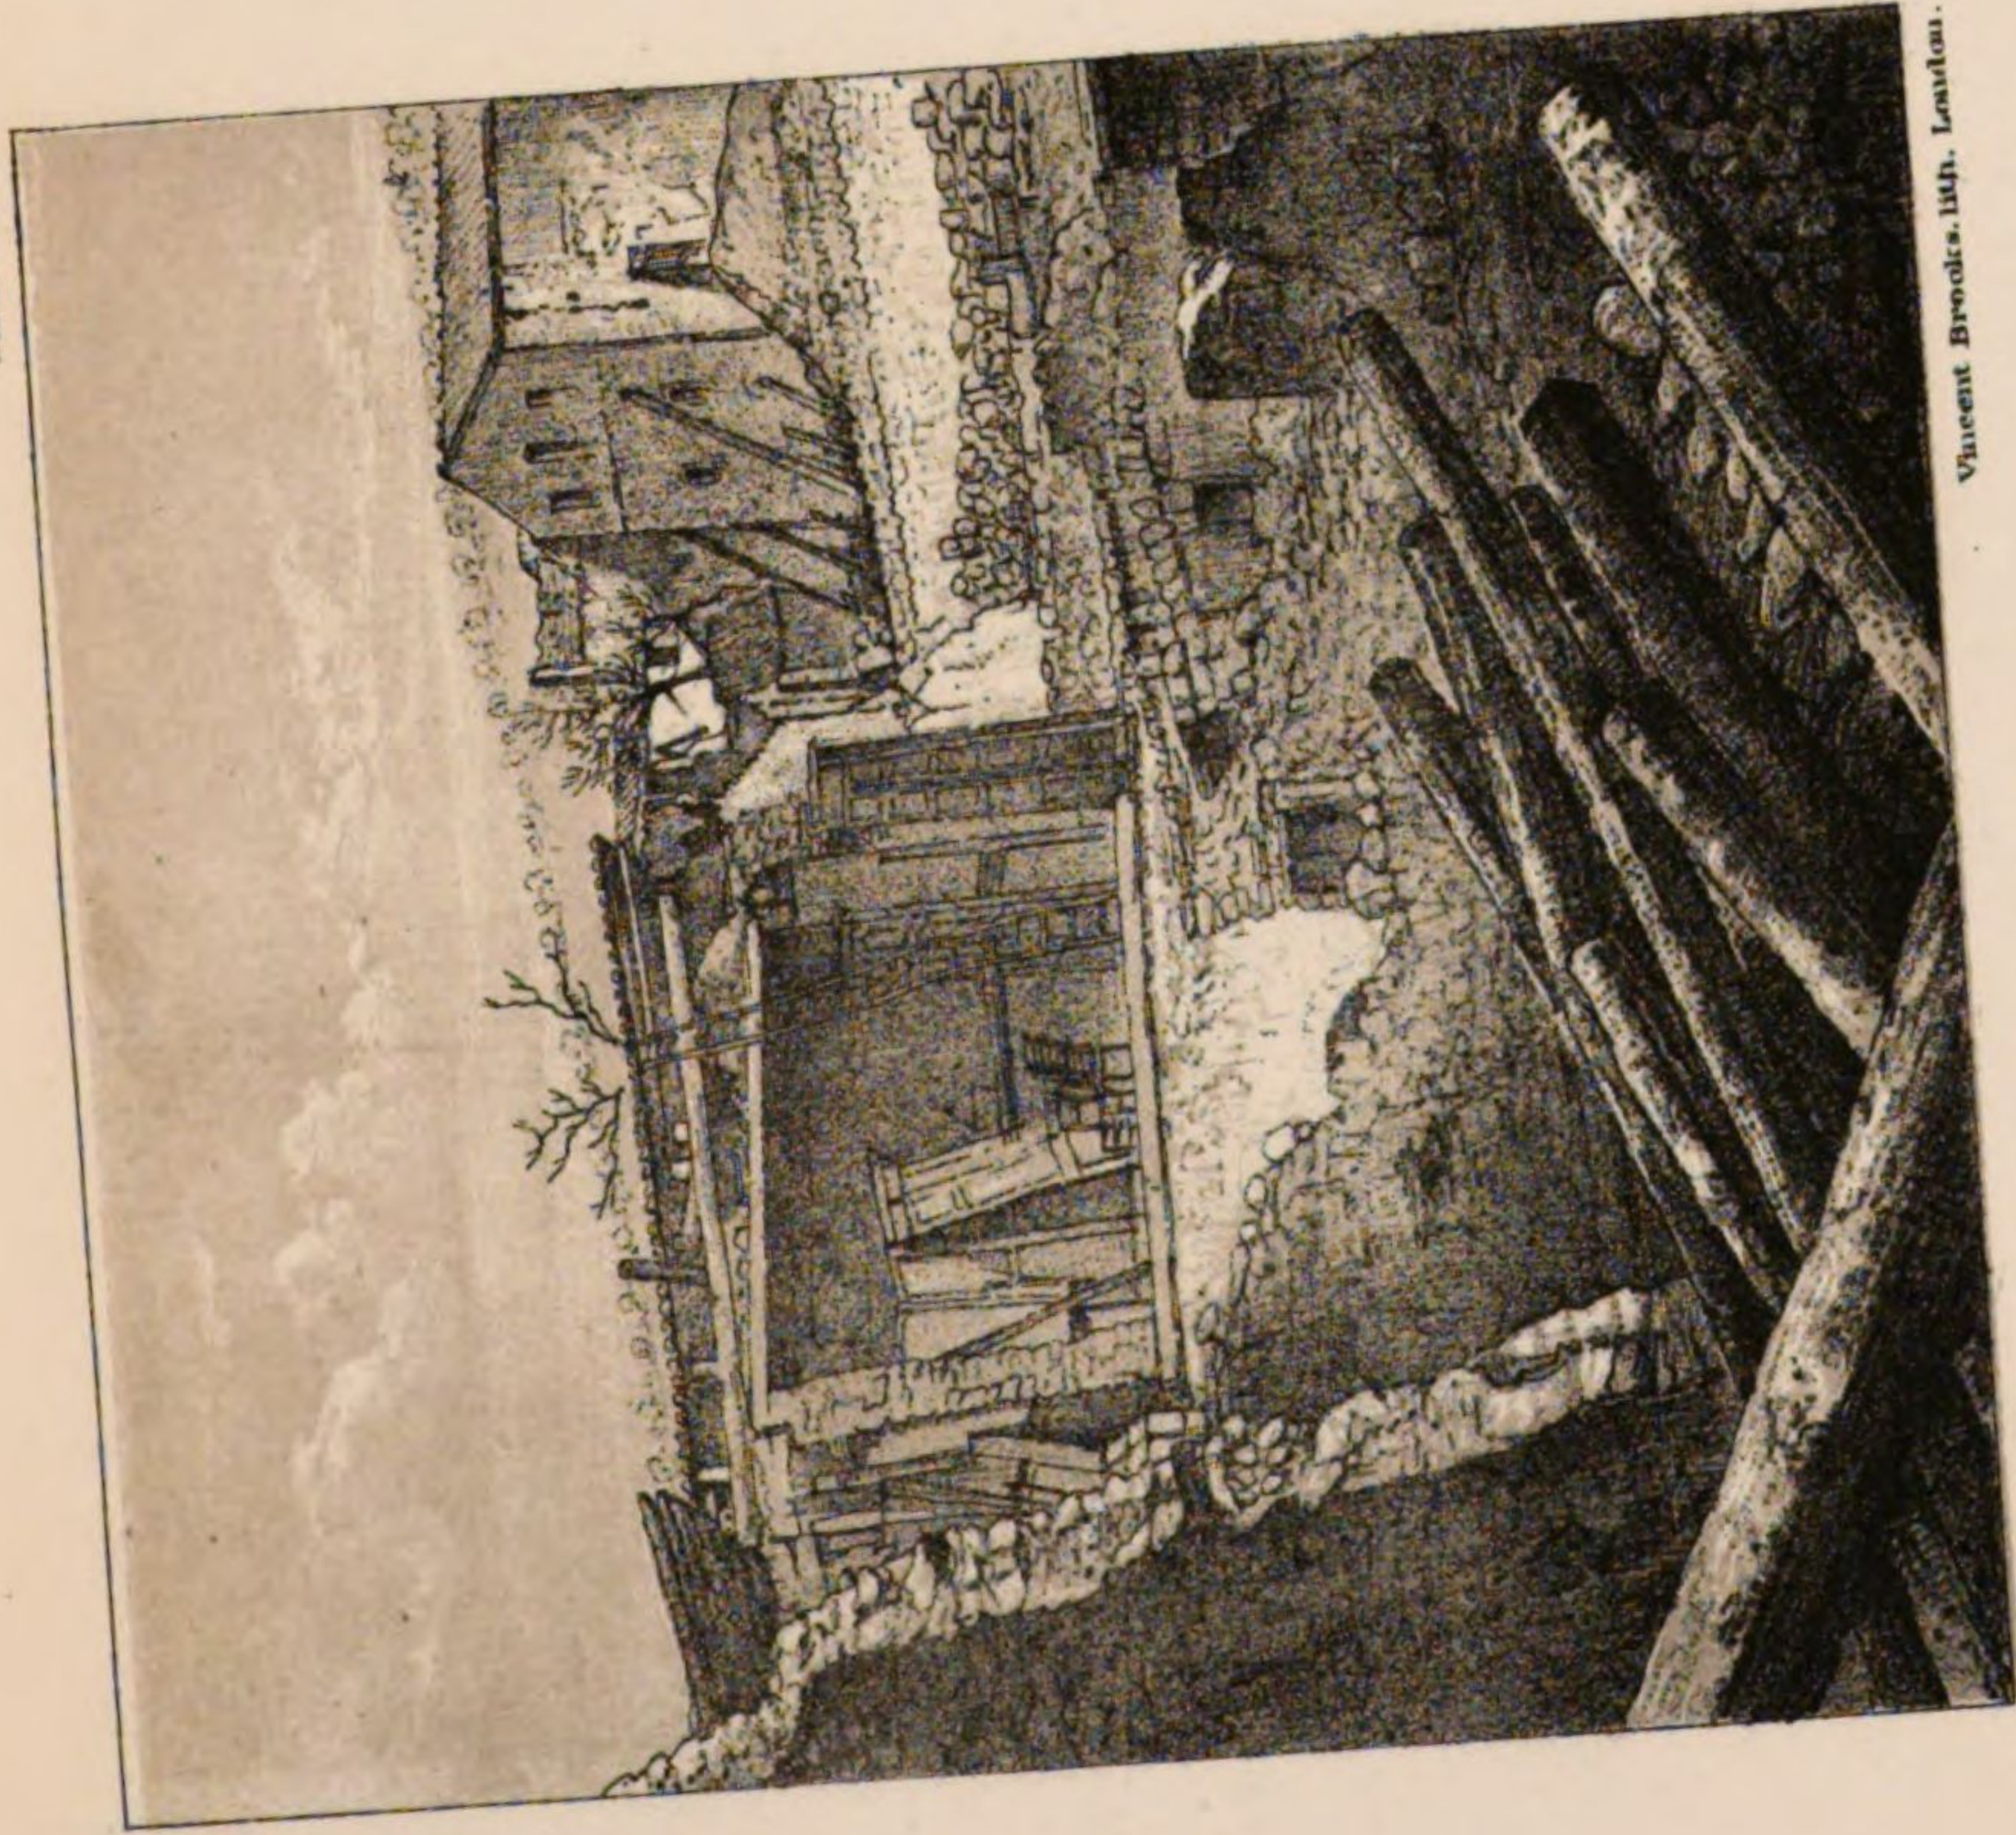
Photo. Pl. 151.

Those No. 150 (Coll. Roy. Soc.) and No. 151 give a tolerable notion of such portions of the town, as presented measureable elements of the direction of shock. The sketch No. 152, taken on the spot, shows a part of the west side in which the lines of street and houses were for

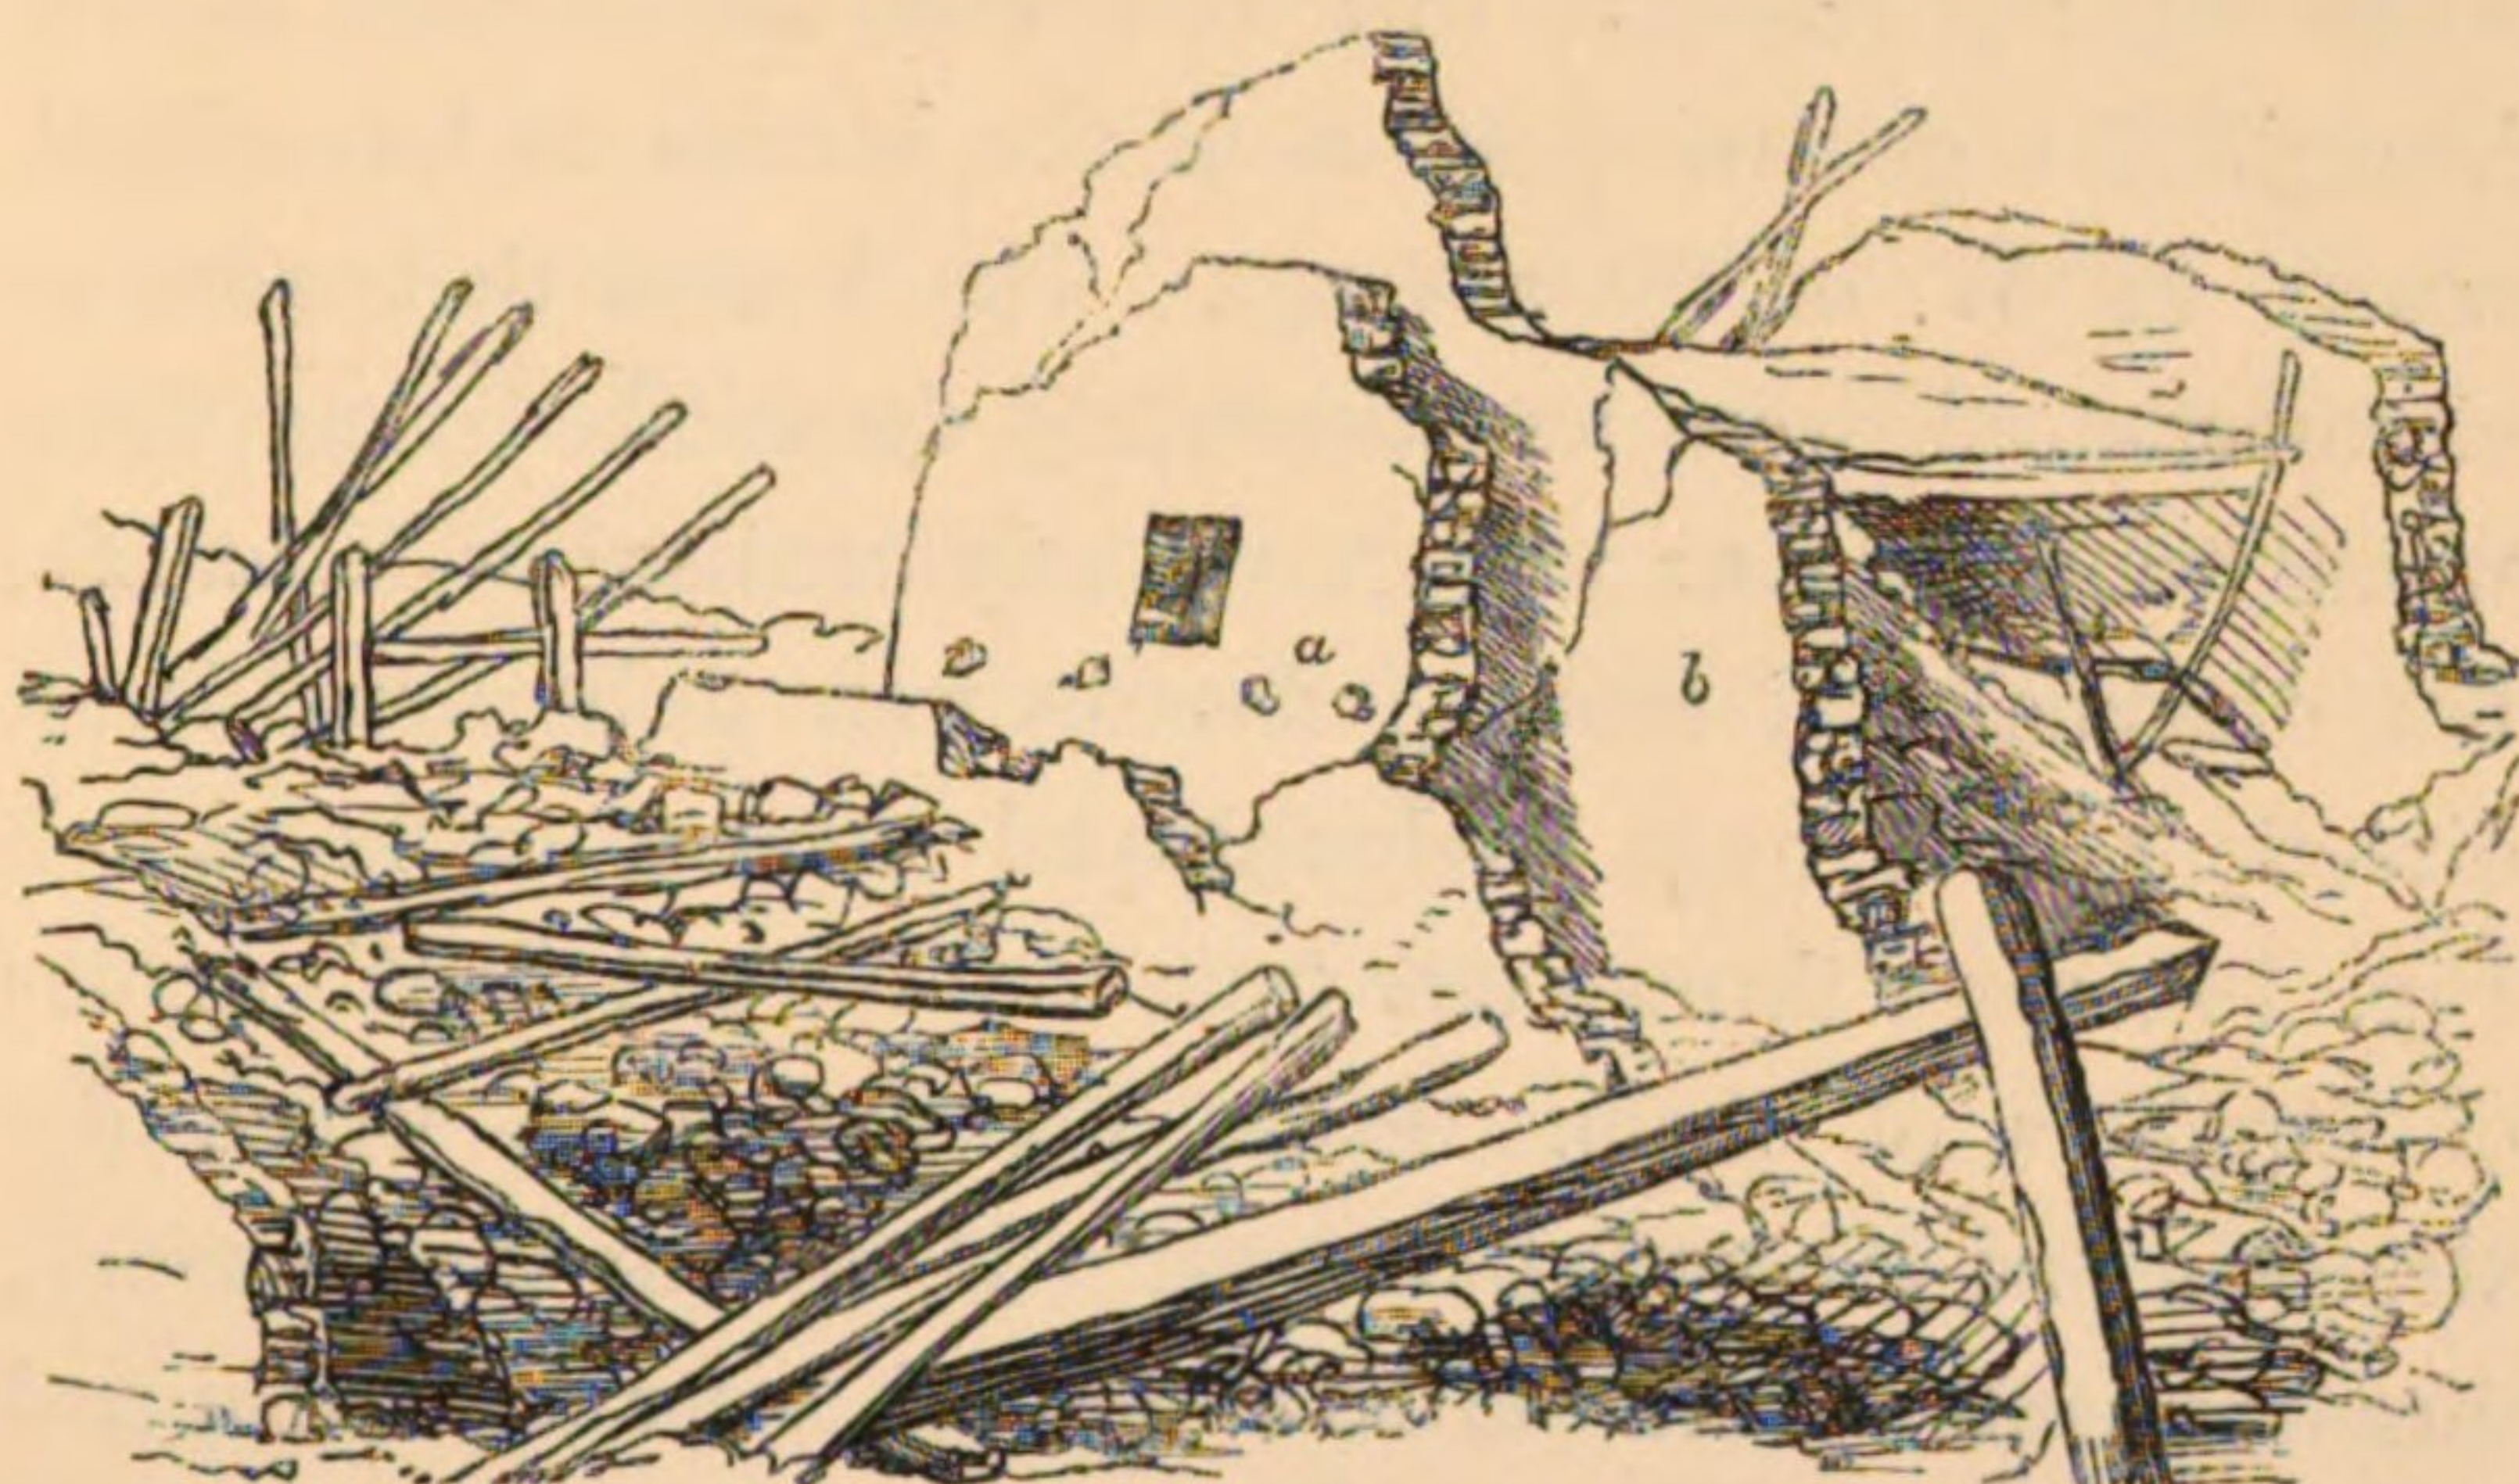
Fig. 152.

a certain range nearly cardinal. The walls *a* and *b*, and all parallel to them, run nearly E. and W. These were in great part, more or less standing, but fissured, in sloping cracks; but the walls whose plane had been N. and S.

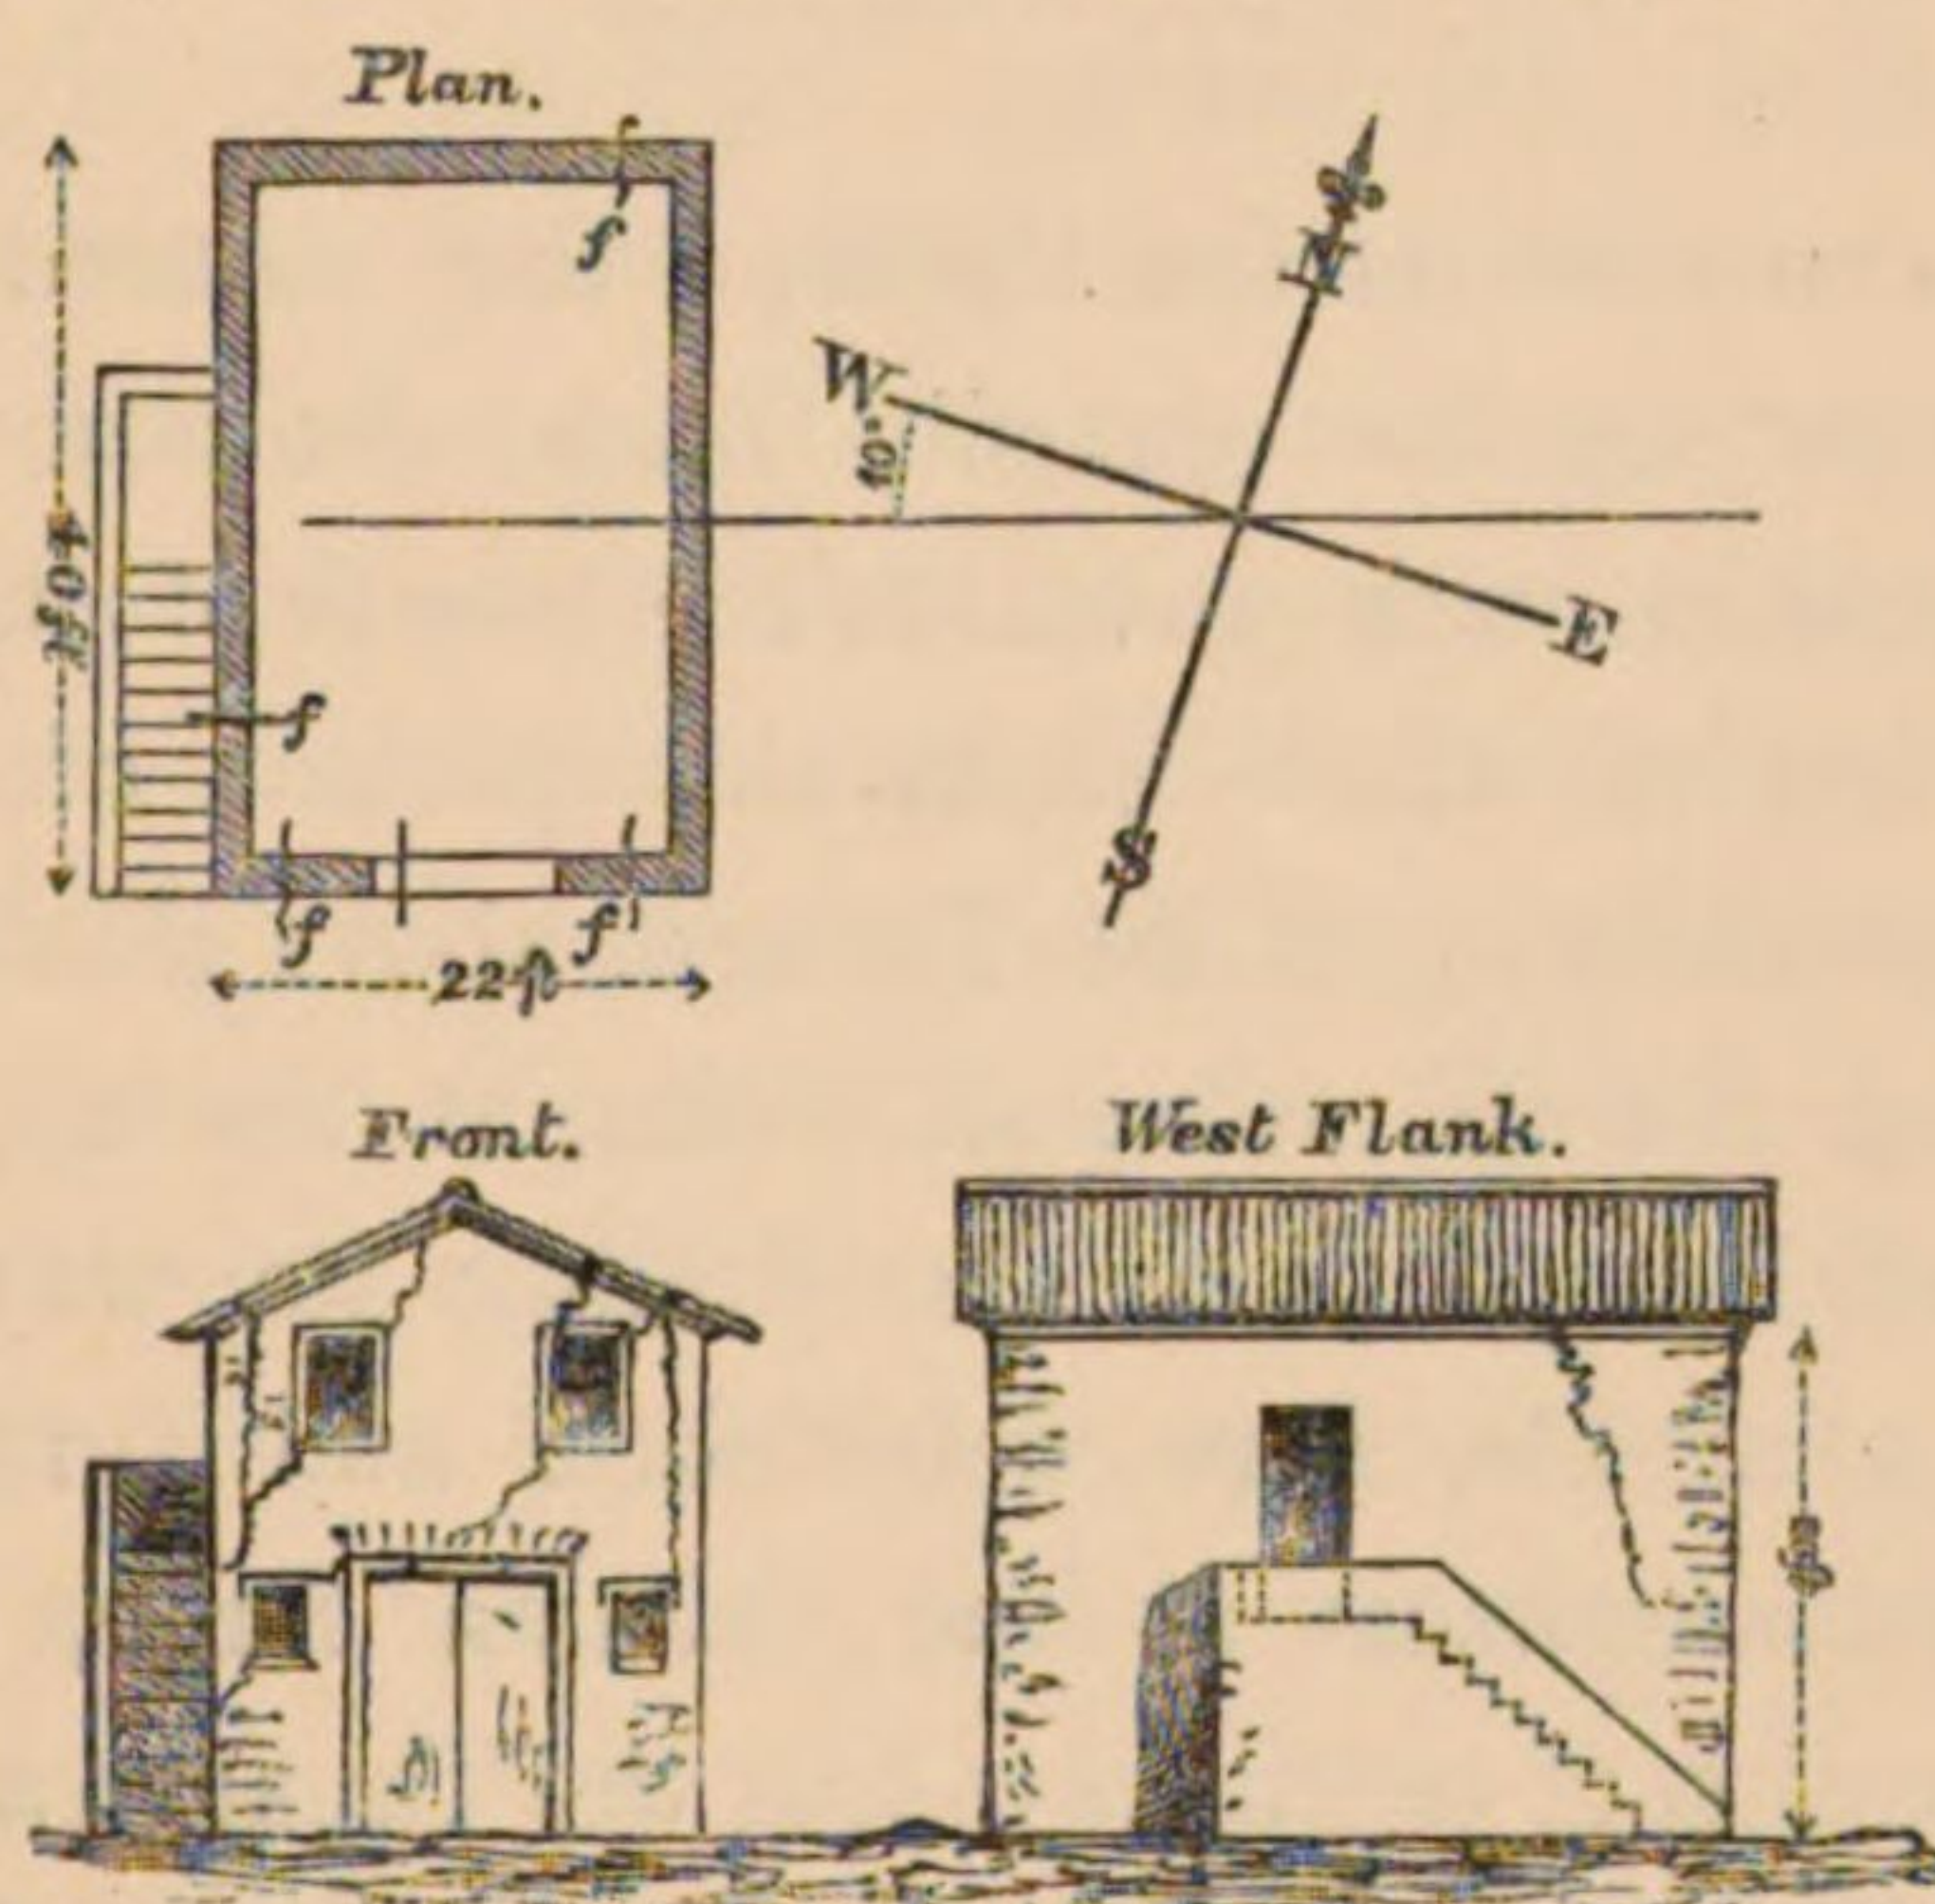
Fig. 153.

Descending with Padre Mancini, from the town to the road at the valley bottom, which is perhaps 100 feet above the bed of the Tanagro close beneath, I examined the little Casa Communale, a nearly new building (about three years old) a parallelogram of two stories (Fig. 153), nearly

cardinal (axial line 10° W. of N.), built of good rubble, with cut stone jamb dressings, and middling quoin stones, and with a heavy external stone staircase on the west flank. It was fissured in several places, and the fractures gave a wave-path of 120° W. of N., and an emergence of about 65° with the horizon. The emergence might be steeper, however, as the direction of the fissures in the front, had been coerced in some degree, by the large proportionate surface, of cut stone jamb dressings.
